# BRE Global Classification Report

## Classification of fire performance in accordance with BR 135: 2013 Annex B for MIB Façades Limited

**Prepared for:** MIB Façades Limited  
**Date:** 18th June 2018  
**Report Number:** P110509-1001 Issue: 1

**Product name:** 136mm-thick MetSIP panel, 60mm-thick Rockwool insulation, 80mm-deep cavity,  
3mm-thick Fusion Facades aluminium cassette panels

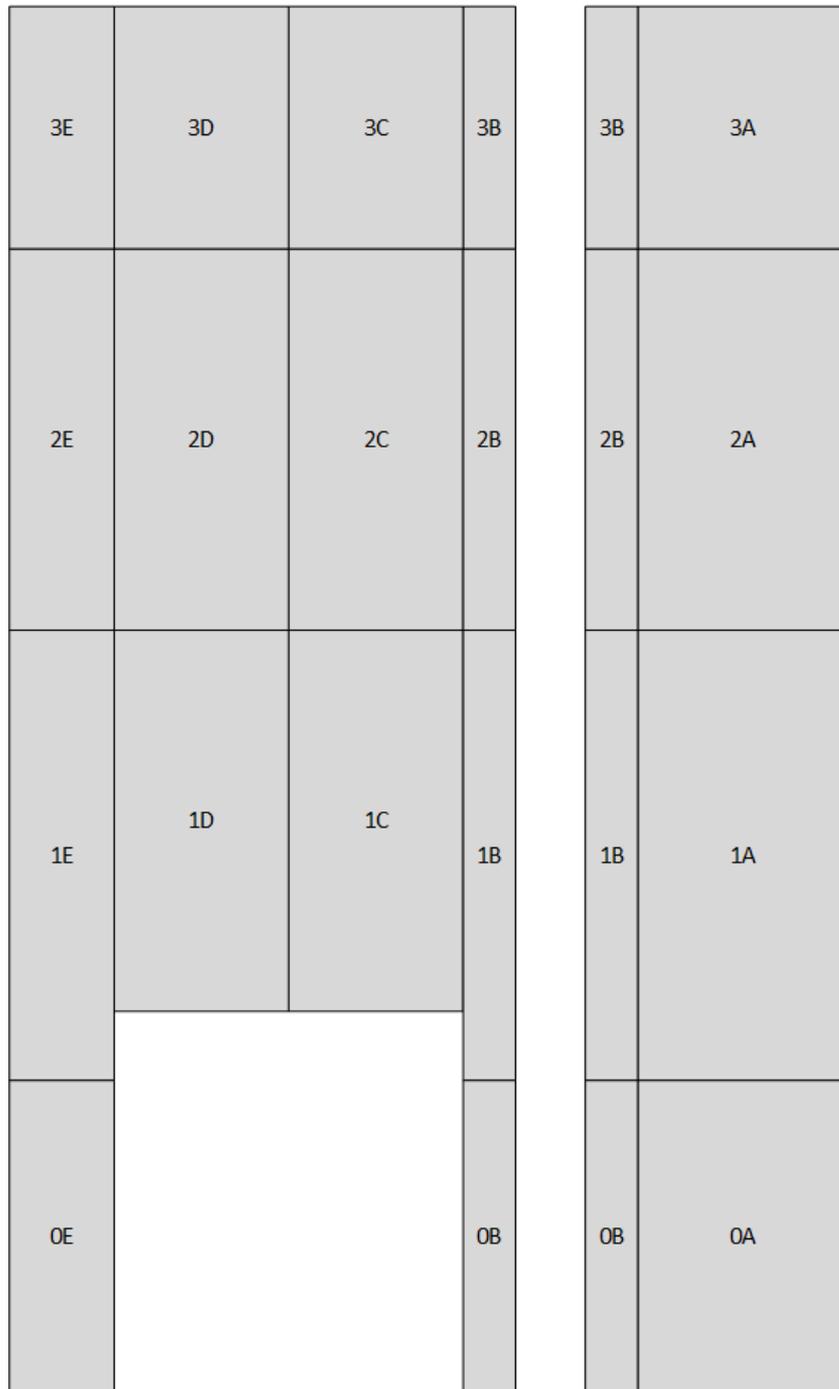
Figure 1. Layout of Fusion Facades panels and numbering system used for reporting. Not to scale

With reference to *Figure 1*, the damage observed to the Fusion Facades aluminium panels was as follows:

- Panel 0A remained intact but was 75% discoloured tapering from the top left corner of the panel, towards bottom right: 15% coating removed, 20% black/dark grey discolouration and a final stage of dark red/brown discolouration approximately 40% surface area.

- Panel 0B remained intact but was 90% discoloured on the wing wall tapering from top to bottom of the panel: 50% coating removed, 20% dark discolouration and 20% dark red/brown discolouration. On the main wall: 40% dark red/brown discolouration, 15% dark discolouration and 40% coating removed and slight distortion (on the combustion chamber return).

- Panel 0E remained intact with a small area (approximately 10%) of dark discolouration along the edge adjacent to the combustion chamber.
- Panel 1A remained intact but was fully discoloured tapering from left to right: 45% coating removed, 5% dark discolouration, 20% dark grey discolouration and 30% dark red/brown discolouration.

- Panel 1B remained intact but had 80% coating removed. Towards the top of the panel on the main wall face there was a small area of dark grey discolouration, and at the base of the panel on main wall an area of dark red/brown discolouration.

- Panel 1C was 50% consumed (outwards from the centre line of the combustion chamber), the remaining panel was discoloured pale orange/yellow with some distortion.

- Panel 1D was 35% consumed (outwards from the centre line of the combustion chamber), the remaining panel was discoloured pale orange/yellow with some distortion.

- Panel 1E remained intact but was 30% discoloured tapering from the vertical edge adjacent to the combustion chamber: silver, black then dark red/brown.

- Panel 2A remained intact but was 30% discoloured tapering outwards from the bottom left corner of the panel: 5% dark grey/black, 25% dark red/brown discolouration.

- Panel 2B remained intact but was 50% discoloured tapering upwards from the base of the panel: 20% silver/dark discolouration, 30% dark red/brown discolouration. On the main wall face the dark red/brown discolouration was visible in locations at all heights of the panel.

- Panel 2C, was 10% consumed (at the base, in line with the centre line of the combustion chamber), and the remaining panel fully discoloured tapering upwards and away from the area of consumed panel: 15% pale orange/yellow, 35% silver, 20% black, 20% dark red/brown discolouration. The panel had some distortion up to mid-height.

- Panel 2D, was 5% consumed (at the base, in line with the centre line of the combustion chamber), and the remaining panel 50% discoloured tapering upwards and away from the area of consumed panel: 10% pale orange/yellow, 30% silver, 10% black and a thin dark red/brown outline. The panel had slight distortion along the base.
- Panel 2E remained intact but was 10% discoloured tapering outwards from the bottom right corner of the panel: <5% silver, <5% dark grey/black, 5% dark red/brown discolouration.
- Panel 3A remained intact and in place with no visible signs of damage.
- Panels 3B-3C remained intact and in place with dark red/brown discolouration along the bottom edge.
- Panels 3D-3E remained intact and in place with no visible signs of damage.
